LIFT CONDITION SURVEY REPORT

Site: Leicester House
Thomas Wyatt Close
Norwich
NR2 2TN

Date of Survey: 8th July 2020

ILECS Ref: CM200382

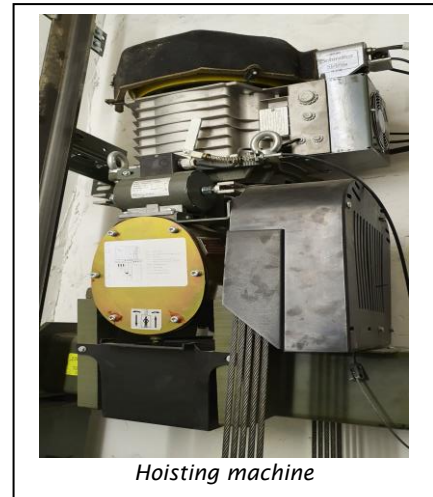
Hoisting machine

- 4.3.1 The hoisting machines are manufactured by Schindler and are as originally installed. Both machines operated in a satisfactory manner with no undue noise or vibration observed. Should refurbishment works be undertaken, we would recommend the units are internally inspected to ensure they are suitable for continued use.

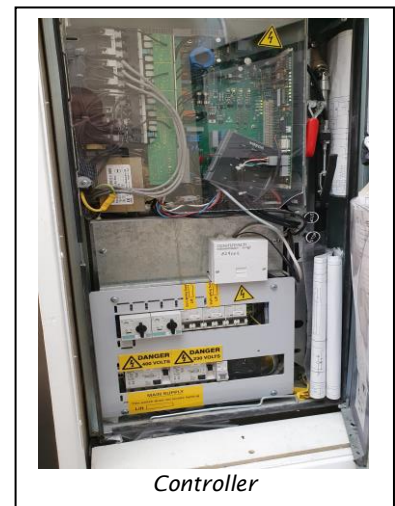
Controller

- 4.4.1 The controllers are showing signs of wear but remain operational. Due to the age and design of the controllers, replacement parts may be difficult to procure in the event of failure, leading to long down times. We would recommend that the controllers are replaced with VVVF drive units and associated controllers, to improve the performance and reliability of the lifts.

- 5.2.1 Refurbish the lifts, incorporating all work as outlined above, replacing the controllers with new VVVF drive units with associated controllers to include full well rewires; install robust car door operators and refurbish all car and landing door equipment, upgrade car and landing signalisation to include compliance where possible with the Equality Act 2010. Thorough Examinations of retained equipment would be undertaken to confirm their condition and suitability for continued use.

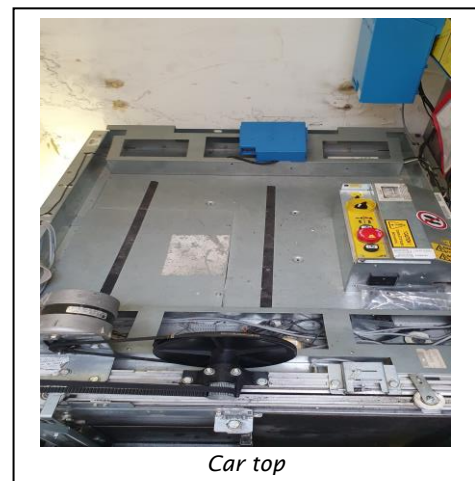
Car top

4.5.1 The car safety gears are operated via overspeed governors located at the top of the lift wells. There is no unintended movement protection or ascending overspeed protection provided for the lifts. We would recommend that the overspeed governors and safety gears are replaced, to provide unintended movement protection and ascending overspeed protection.

4.5.2 The car top controls do not comply with current standards, as they do not incorporate common buttons, enabling them to be inadvertently operated. The car top controls should be replaced with compliant units.

4.5.3 The car and counterweight oil pots should be replenished at next service.

4.5.4 RCD protected sockets should be installed to the car tops.

4.5.5 A safe refuge area should be marked on the car tops.

- c) Mark the safe refuge areas in the lift pits and car tops
- d) Install power sockets with an RCD device to the car tops
- e) Paint the counterweights warning yellow
- f) Provide unintended movement protection
- g) Provide ascending overspeed protection
- h) Replace the car top controls

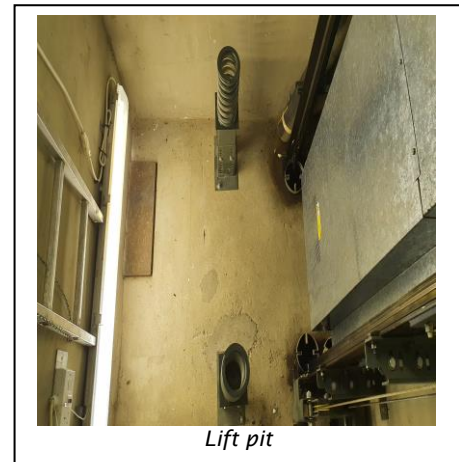
- 4.6.1 The lift pits were found to be clean and tidy, with a removable pit access ladder in Lift SW5, pinned to the lift well wall for safe access and egress. The access ladder for Lift SW4 is located in the cleaner's cupboard.
- 4.6.2 Safe refuge areas should be marked within the pits.

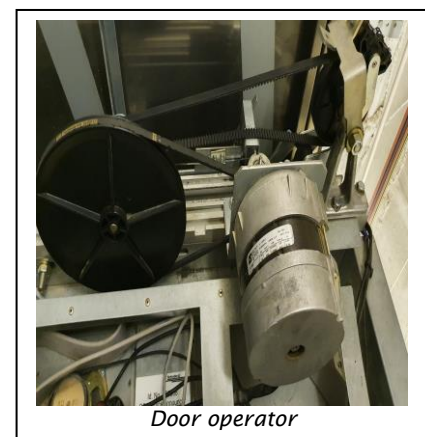
- 4.7.1 The landing entrances are lightweight by design and value engineered throughout; however, the doors were found to be in a serviceable condition.
- 4.7.2 Consideration should be given to upgrading the landing signalisation and to comply where possible with the Equality Act 2010.
